RESEARCH MEMORANDUM

CYCLIC ENGINE TEST OF CAST VITALLIUM TURBINE BUCKETS - I

By J. Elmo Farmer, F. N. Darmara
and Francis D. Poulson

February 19, 1948

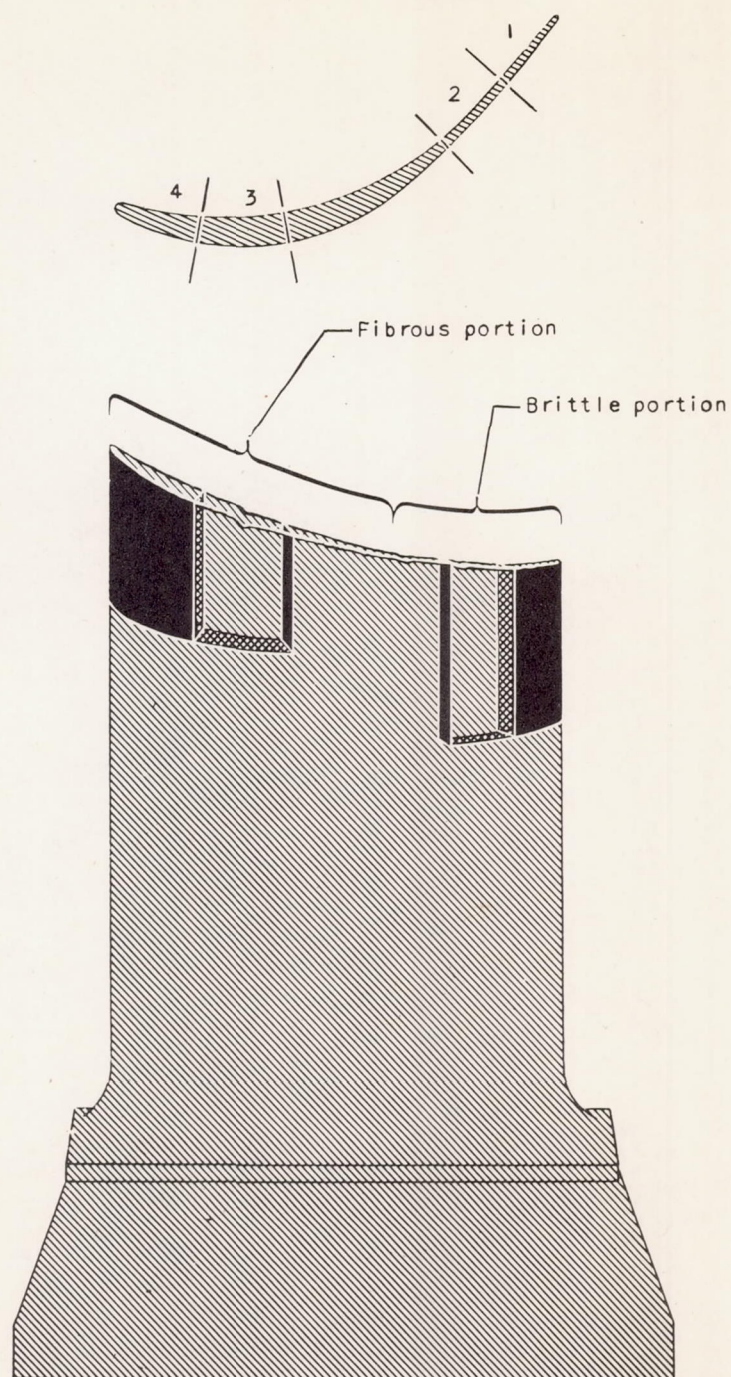
Microexamination. - Two samples were cut from both the leading and the trailing edges of the broken buckets. The locations from which the samples were taken are shown in figure 5. The samples were polished and electrolytically etched in hydrochloric acid.

Figure 5. - Sketch showing location of samples cut from broken turbine buckets for microexamination. Black areas indicate polished surfaces.

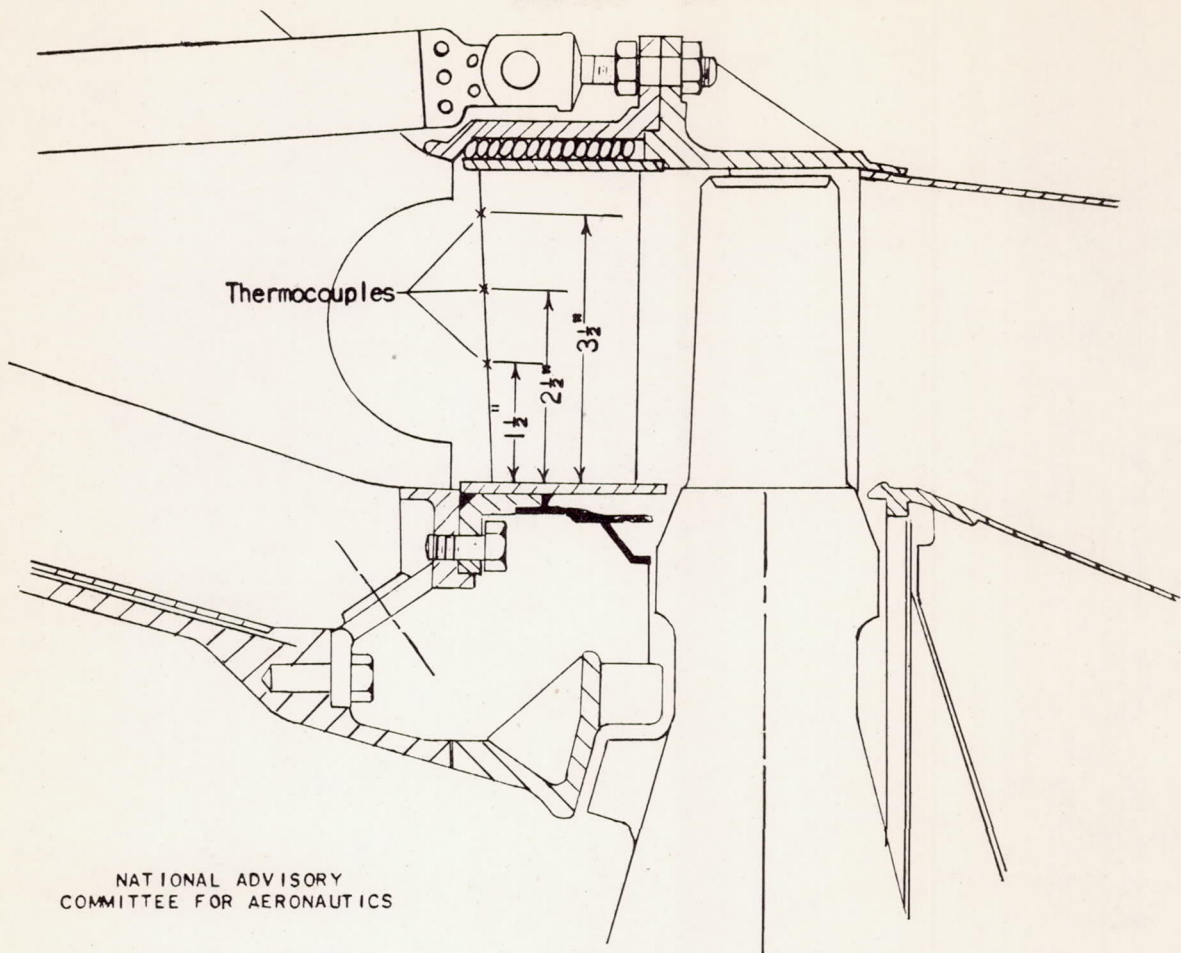
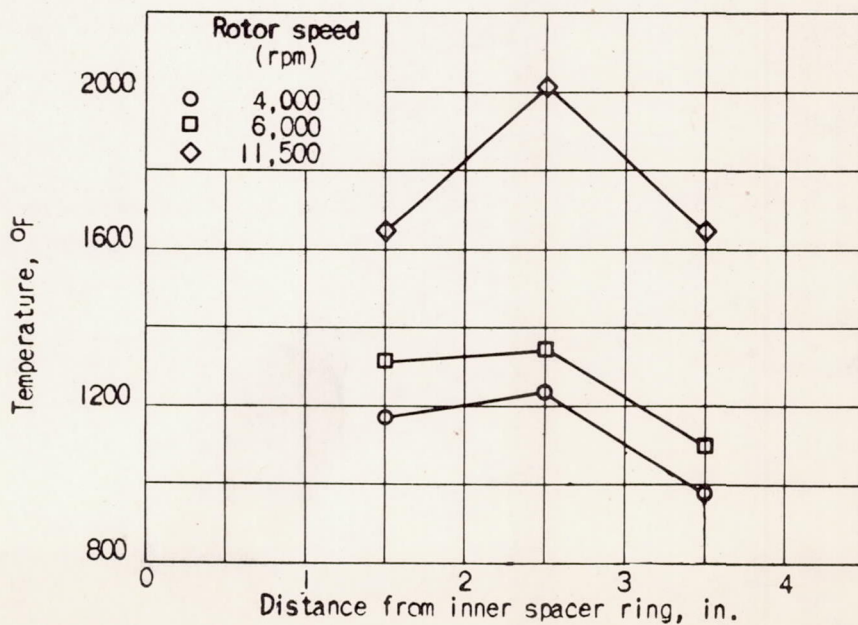
Nozzle-blade temperature. - The temperature variation along the leading edge of a turbine-nozzle blade located directly behind burner 1 is shown in figure 14. These temperatures were obtained by three chromel-alumel thermocouples located as shown in figure 14.

Figure 14. - Temperature variation along leading edge of turbine-nozzle blade on center line of burner 1 in turbojet engine at various rotor speeds.
